TadiVac2000 Analysis Report For Chip¹ Semiconductor CVD1 / CVD2

Revision: 03

Purpose and scope

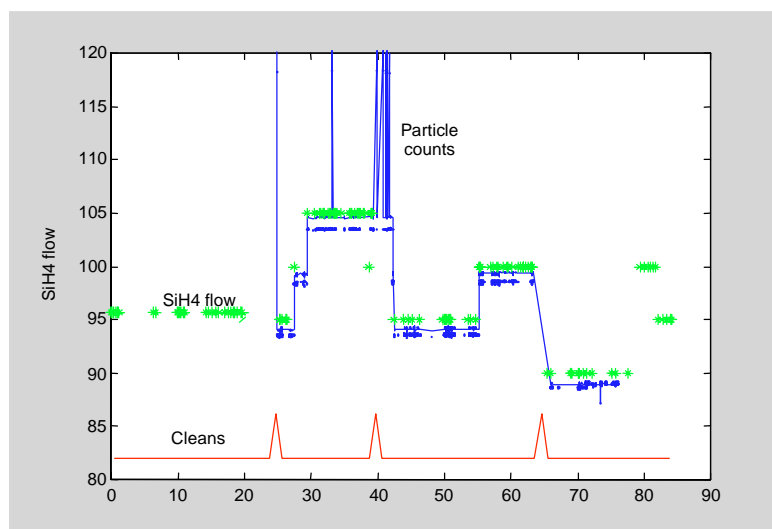
As can be seen on the following graphs, the critical parameter with high correlation to particle-count is the Silane flow-rate. As long as the Silane flow is maintained below 95 SCCM, the particle count is kept under the spec limit. When the flow exceeds 95 SCCM a rapid increase in the particle count is detected. Above 105 SCCM the particle count is occasionally extremely high (More than 10 times the spec limit) and other machine's parameters such as pressure control become highly unstable. Furthermore, it can be seen on most trends that in the period between Feb 5 and Feb. 16 the Silane flow was kept under 90 SCCM (Actually, about 87) the particle counts where very low and ALL parameters where very stable. See the pressure control valve, the pressure, the RF power, etc.

Silane flow correlated with Particle Counts

1. The Silane flow-rate is a critical parameter in regards to particle buildup.
2. The Silane flow is set at a critical level with no process latitude. It is recommended that the Silane and N2O flow-rates will be experimented and set to allow for sufficient process latitude.

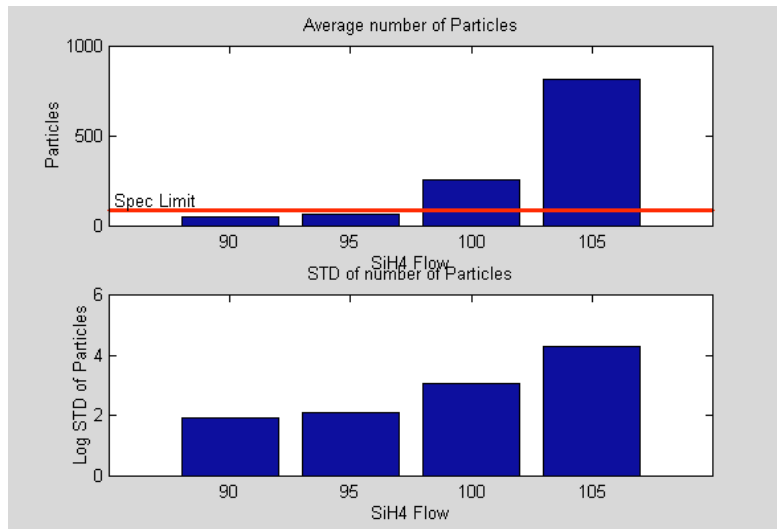
Histogram of Particles vs. Silane flow

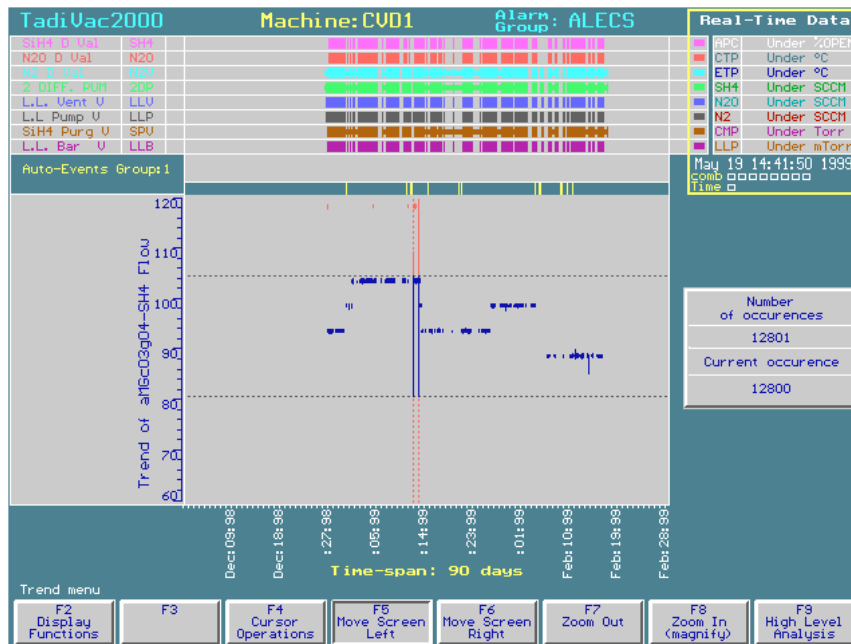
Silane flow parameter trend

The flow variations were said to be manually set.

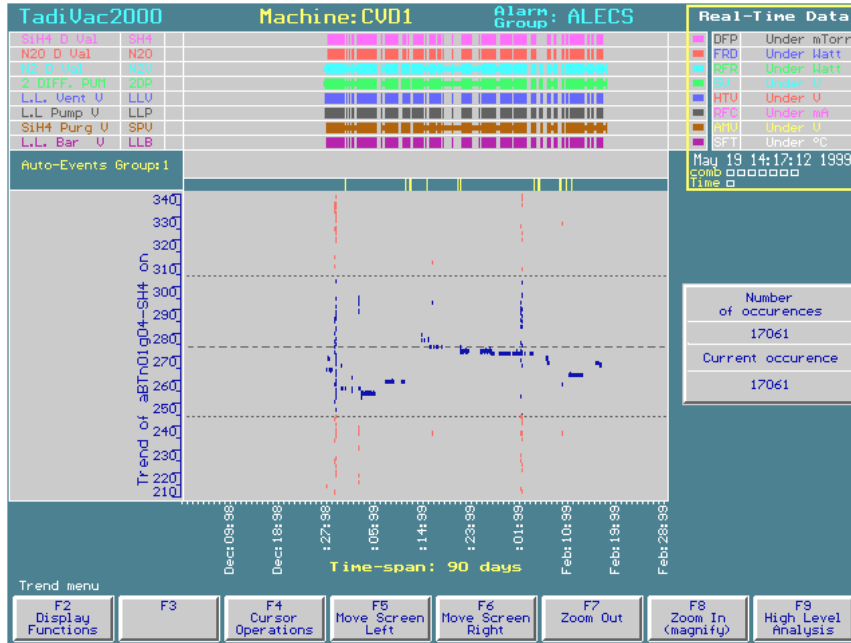
Silane 'ON' time parameter trend

3. The Silane valve's 'On' time is unstable as can be seen of the Silane Time Trend graph.
4. The particle build-up and the unstable parameters such as pressure and pressure control are suspected to be the result of the chemical reaction of Silane with Oxygen that rapidly converts gas into solid, causing rapid, unpredicted and unstable pressure drops.

This parameter shows the trend of the Silane valve 'on' time that is very unstable.

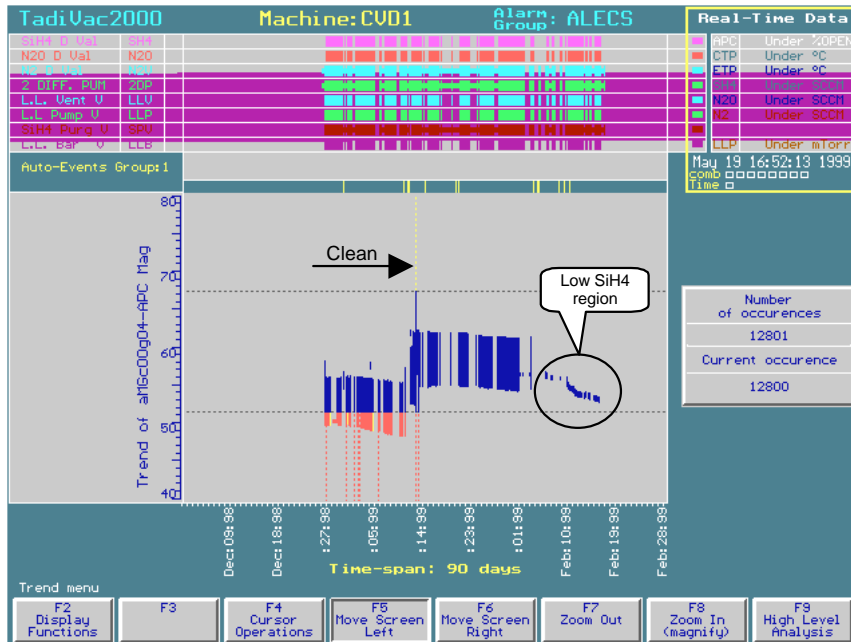
APC (Automatic Pressure Control Valve position) vs. time parameter trend

APC Valve position trend. Note trend and clean

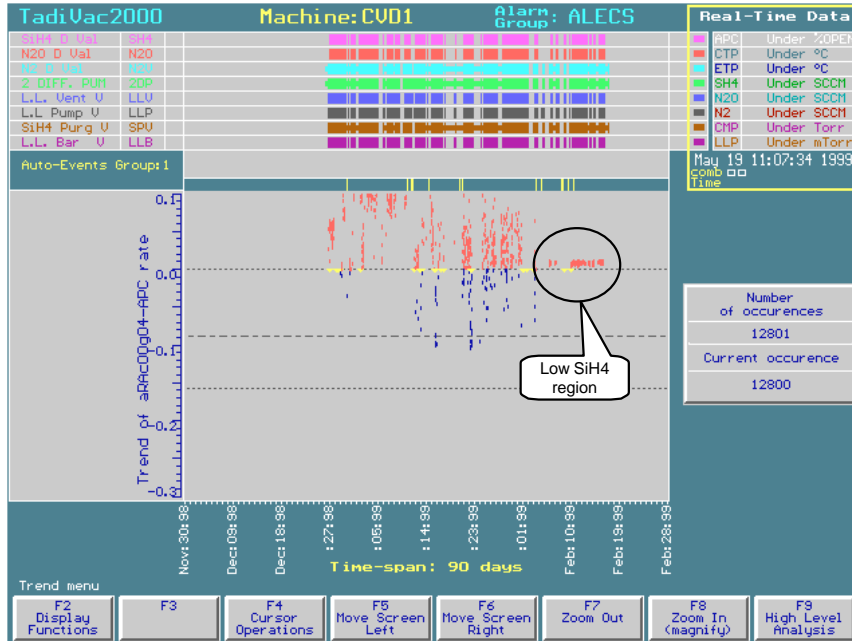
APC rate-of-change after SiH4 is applied parameter trend

The APC valve rate. Note stability at low SiH4 flow.

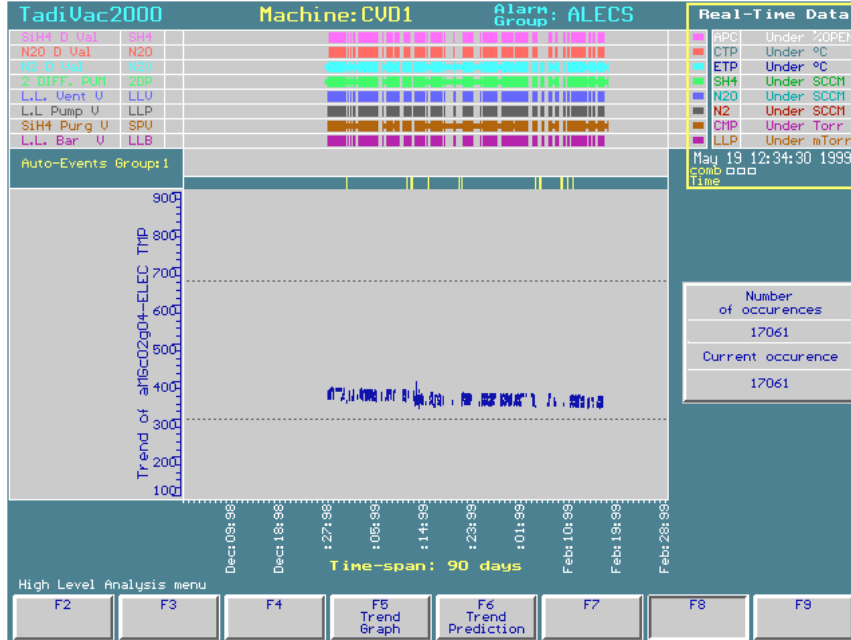
Electrode Temperature #2 parameter trend

Note slight trend.

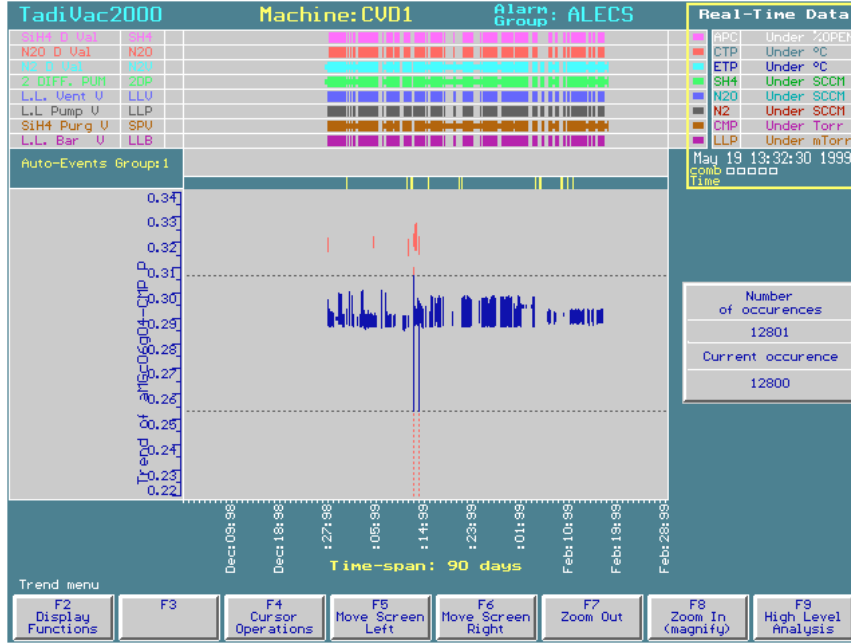
Chamber pressure parameter trend

Note: When SiH4 is high, the Pressure has wide range.
At low SiH4 flow the pressure is stable.

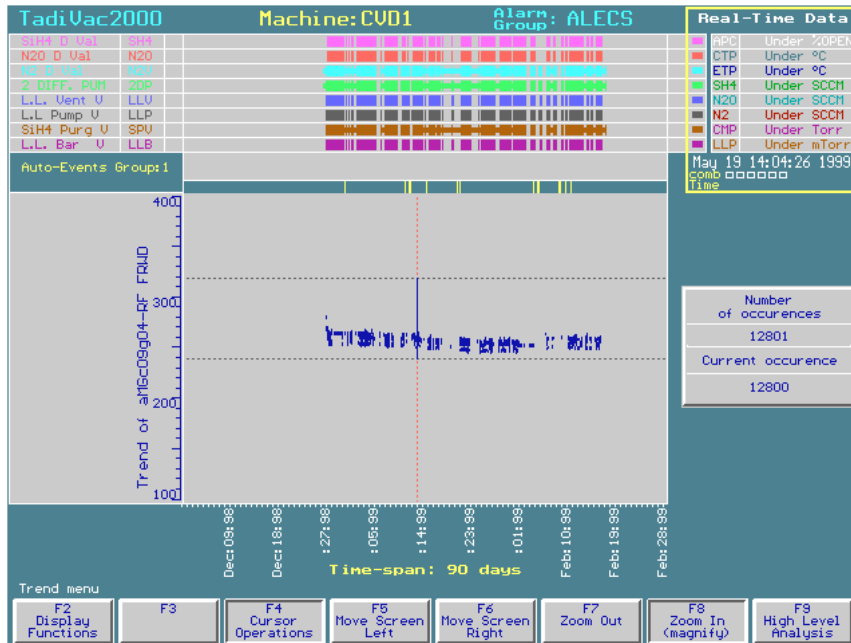
RF Forward power parameter trend

Note slight RF power drift.

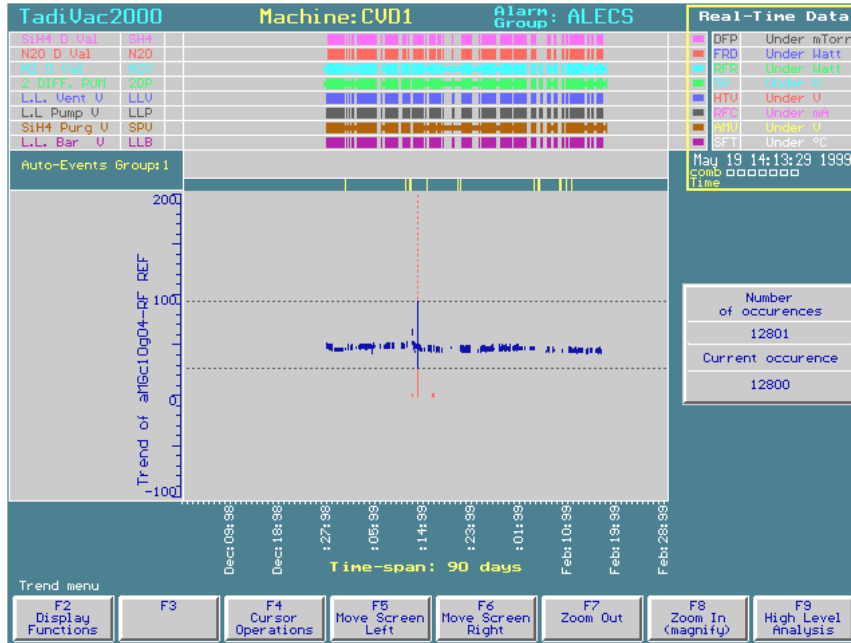
RF Reflected power parameter trend

Note: The RF Reflected has some variation correlated to the RF Forward.

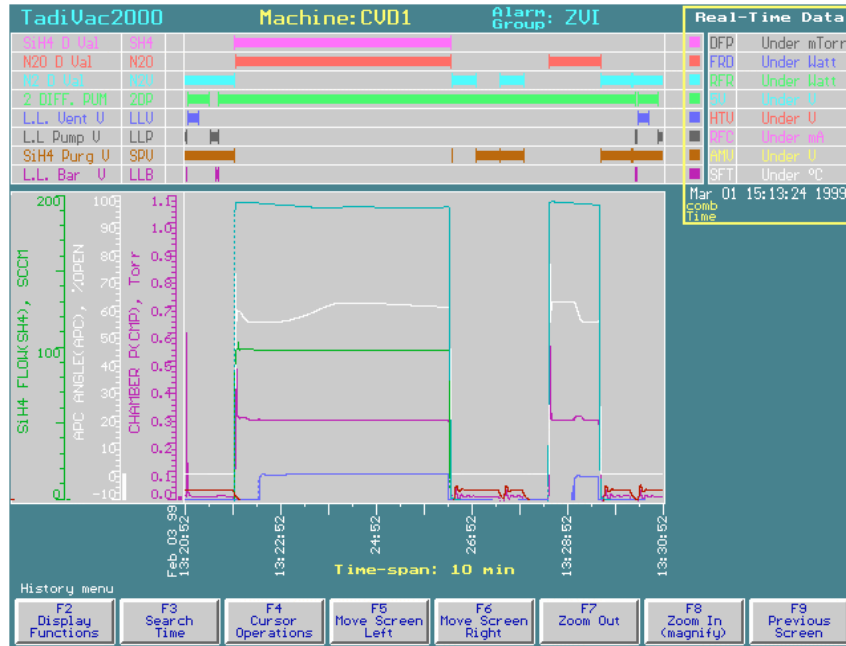
At high Silane flows, the APC valve is unstable.

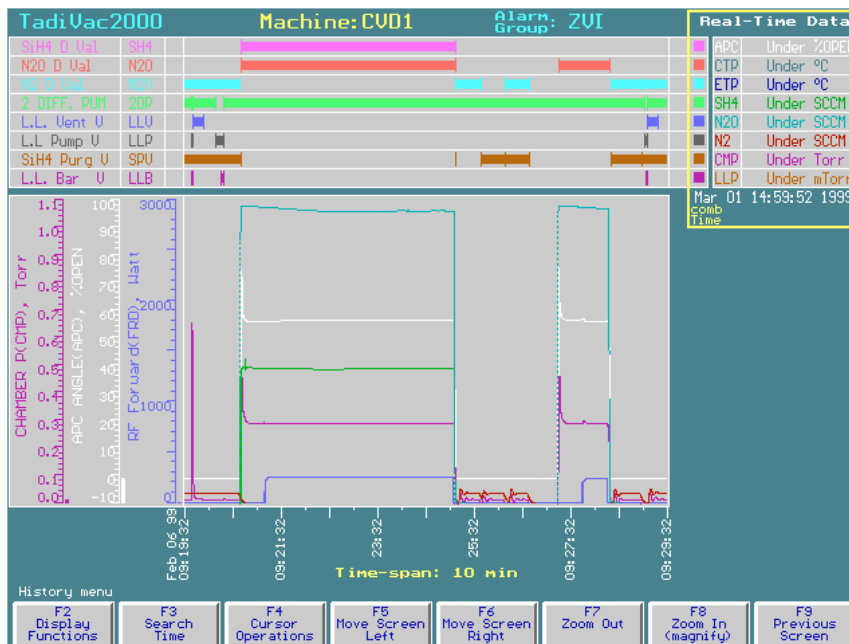
At low Silane flow, the APC valve is stable. (With slight overshoot)

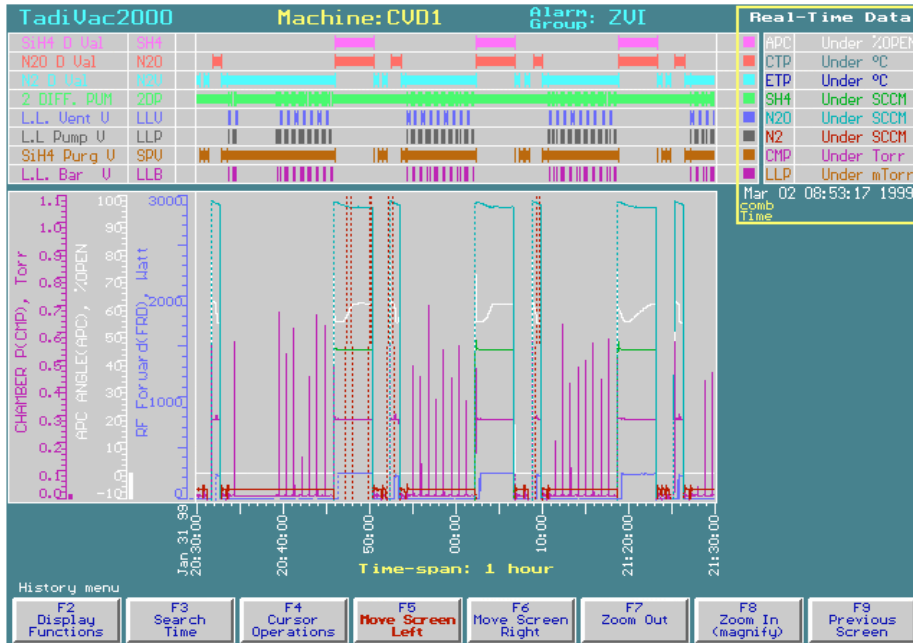
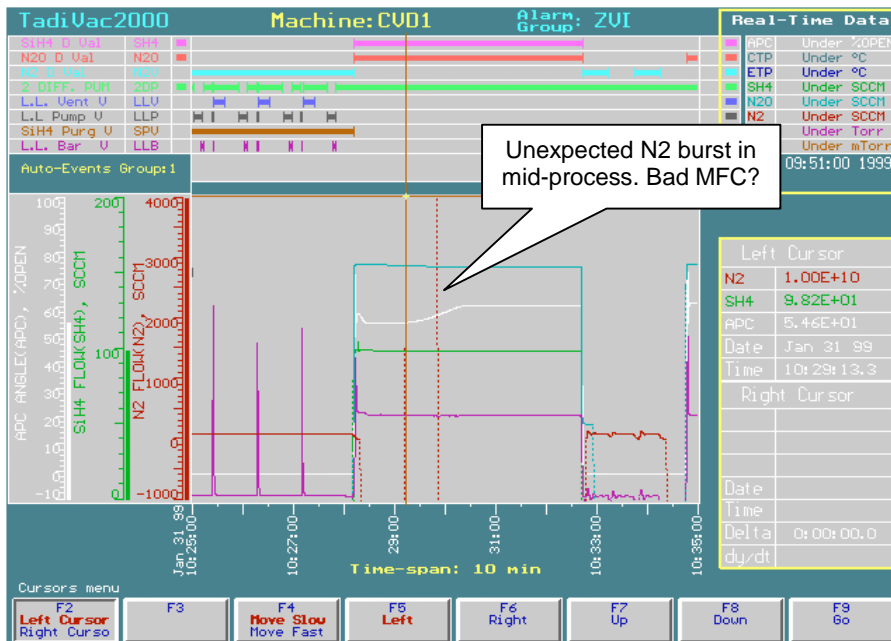
6. In CVD1, an unpredicted opening of the N2 valve or MFC in the middle of the process was observed. It needs to be checked. (Page #12)
7. An arm motor excess current in CVD2 indicates that the arm is probably hitting the inner door. This may cause particles and wafer breakage. Needs to be adjusted. (Page #17)

During a regular process, an unexpected opening of the N2 MFC was observed,

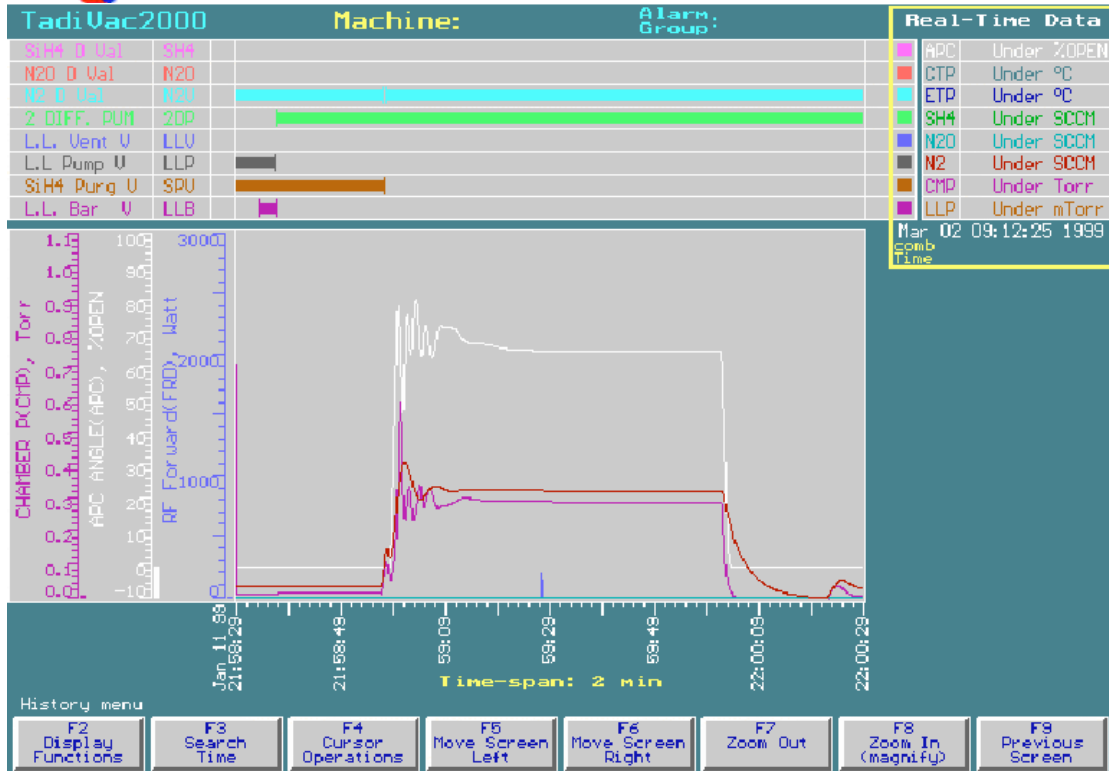
CVD1, Trikon
Poor Pressure control.

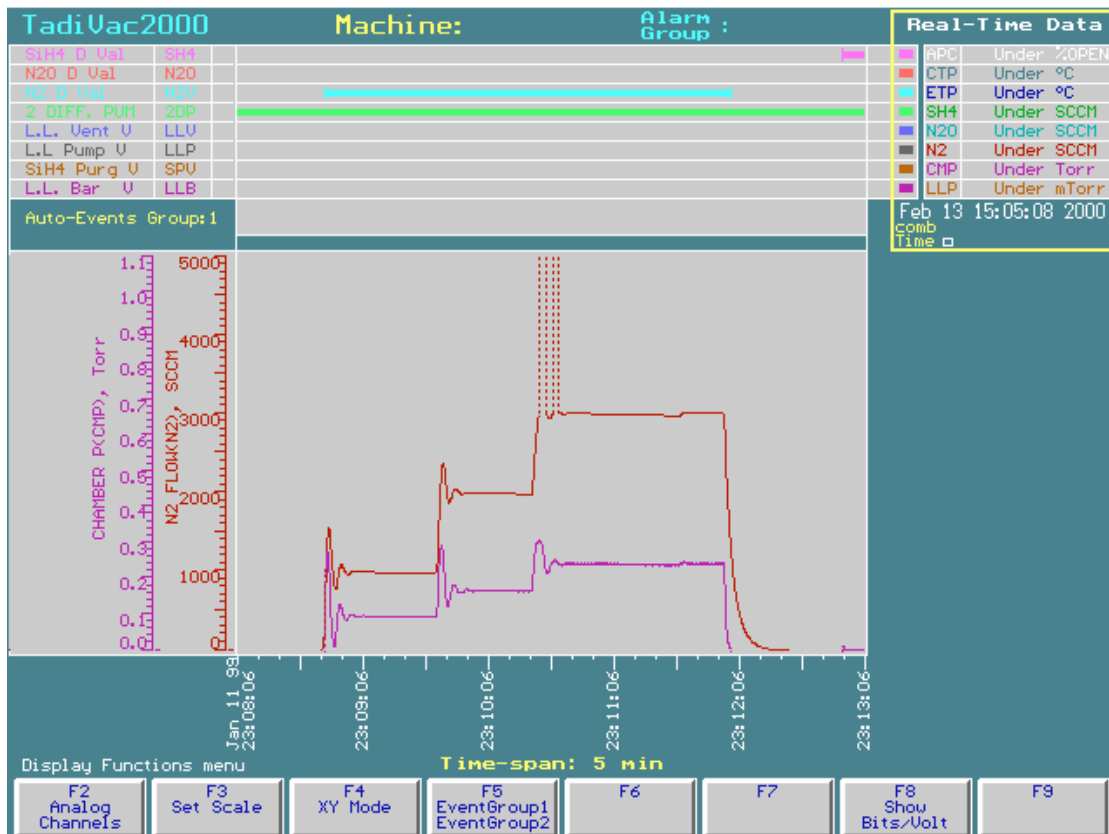
CVD1

After clean, the machine goes trough an unstable period. we can see difficulty in pressure stabilization.

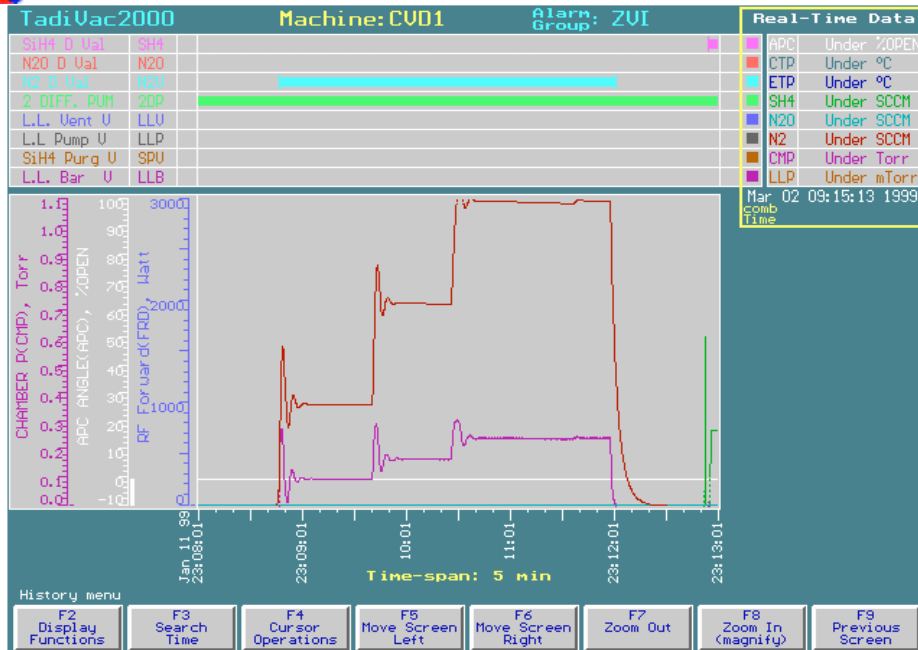
Testing the N2O MFC shows unstable operation. May indicate excess N2O pressure and / or a need for MFC adjustment.

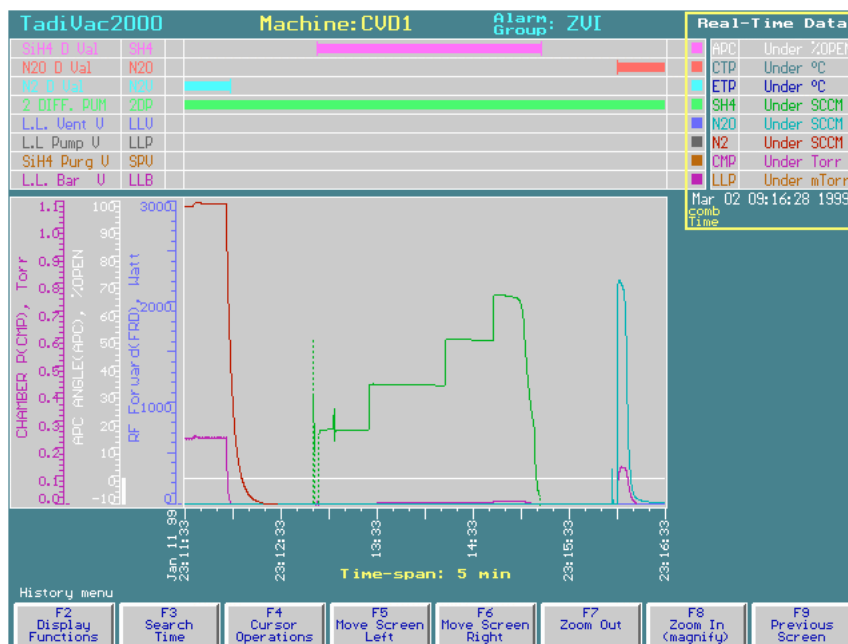
N2O and SiH4 MFC ramp up tests show proper operation

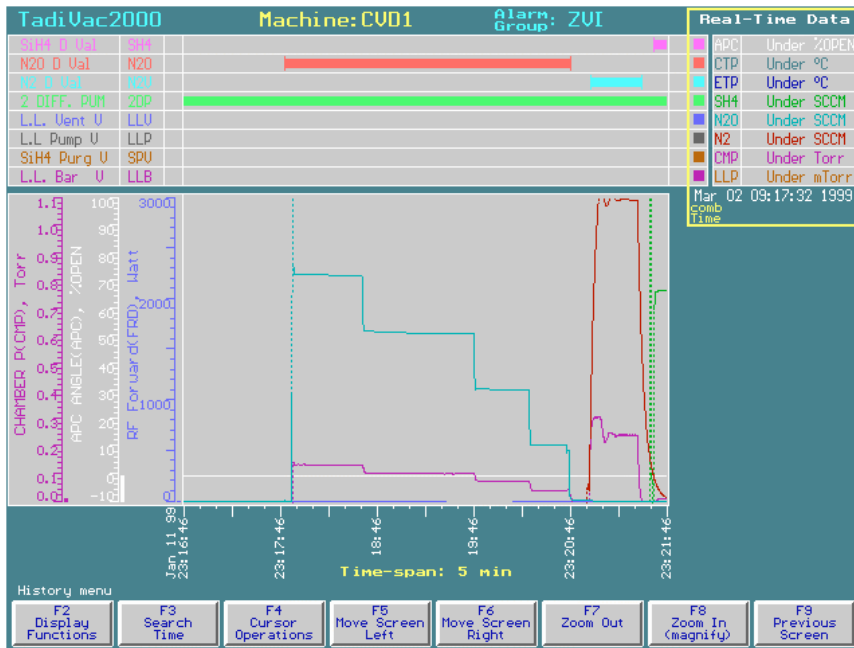
N2O and SiH4 MFC ramp down tests show proper operation

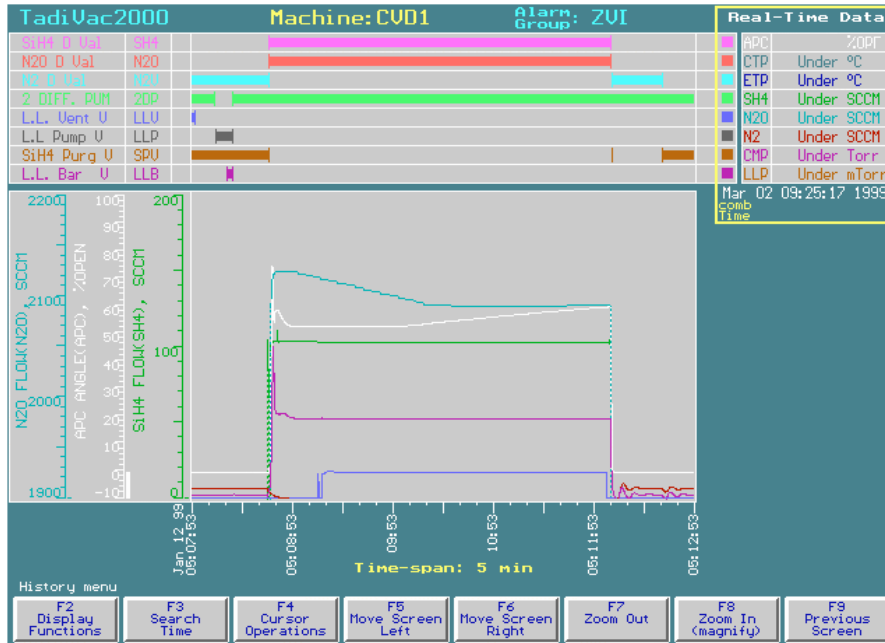
A more careful observation of N20 MFC operation after clean reveals that a drift of flow is present during process. This drift might not be a cause for problems in this process, but in general it is recommended to have a stable flow.

Process after clean. N20 MFC has drift from 2130 to 2090 SCCM. The SiH4 flow is 103 SCCM (too high).

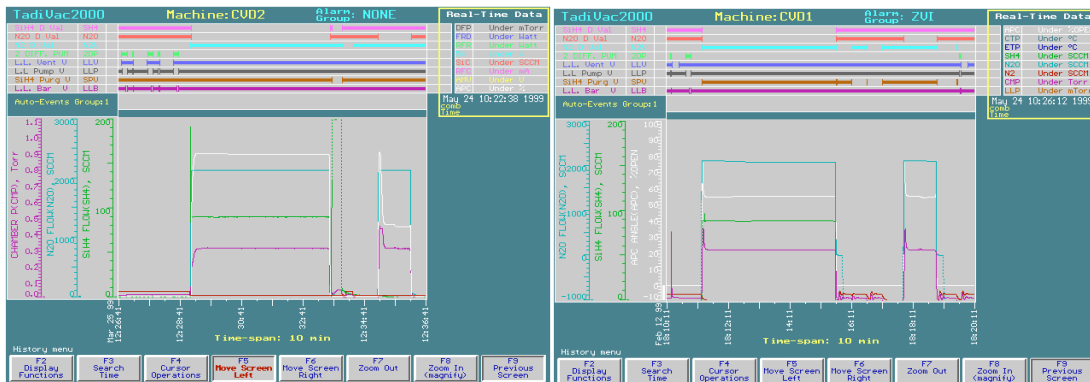
By comparing the fingerprint of CVD1 and CVD2 one can easily see that the two machines work differently. Although the flow and pressure levels are almost the same the process sequence and APC operation are very different.

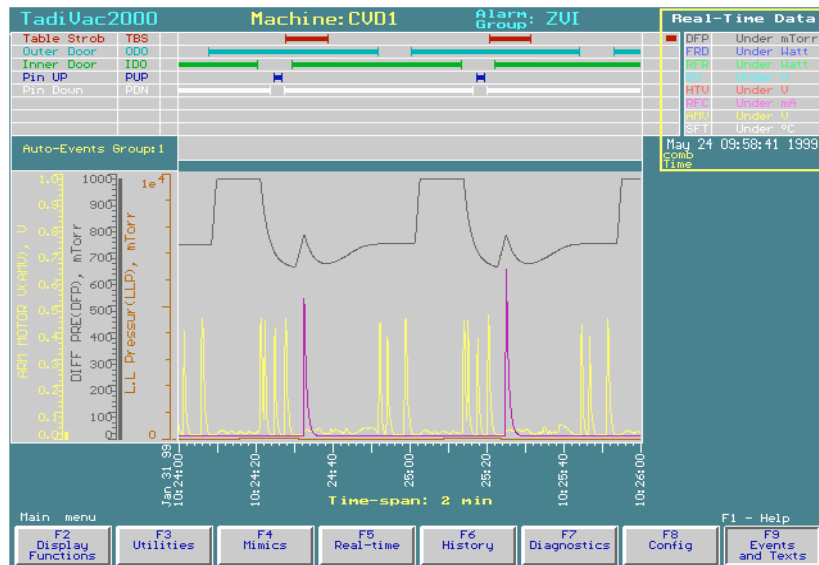
5. A leak or insufficient pumping in CVD1 load-lock can be observed. This results in pressure bursts in the chamber that can cause Oxygen (air) in the chamber and particles. (Page #16)

The data shows clearly that CVD1 differential pressure is too high, causing pressure bursts in the chamber each time the inner door is opened to load a new wafer. There might be a leak or insufficient vacuum pumping at the load lock chamber.

The pressure bursts can cause high Oxygen level in the chamber that can be the reason to many if not most process problems.

CVD1 Load-lock pressure. Note the high level of pressure and the chamber pressure bursts when the inner door opens.

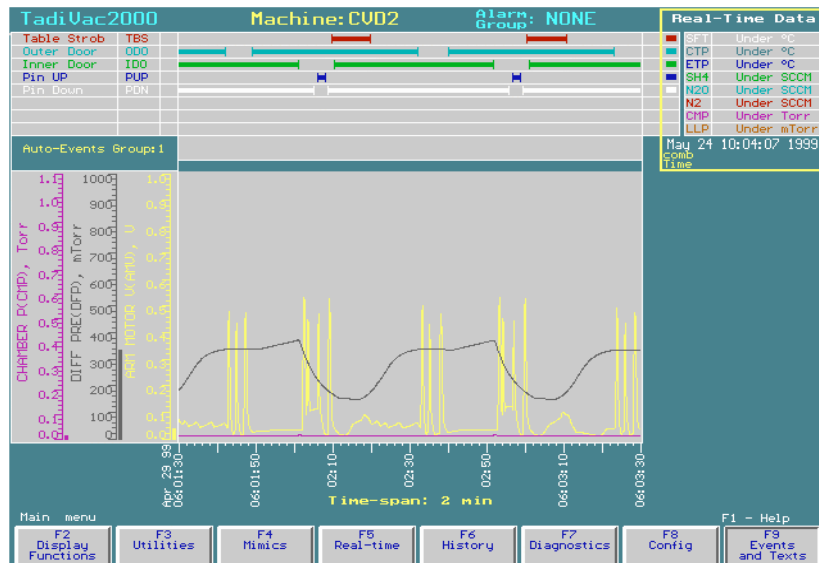
As a reference, CVD2 Load-Lock pumping seems normal. The LL pressure level is sufficiently low, there is no pressure increase in the chamber when the inner door is opened.

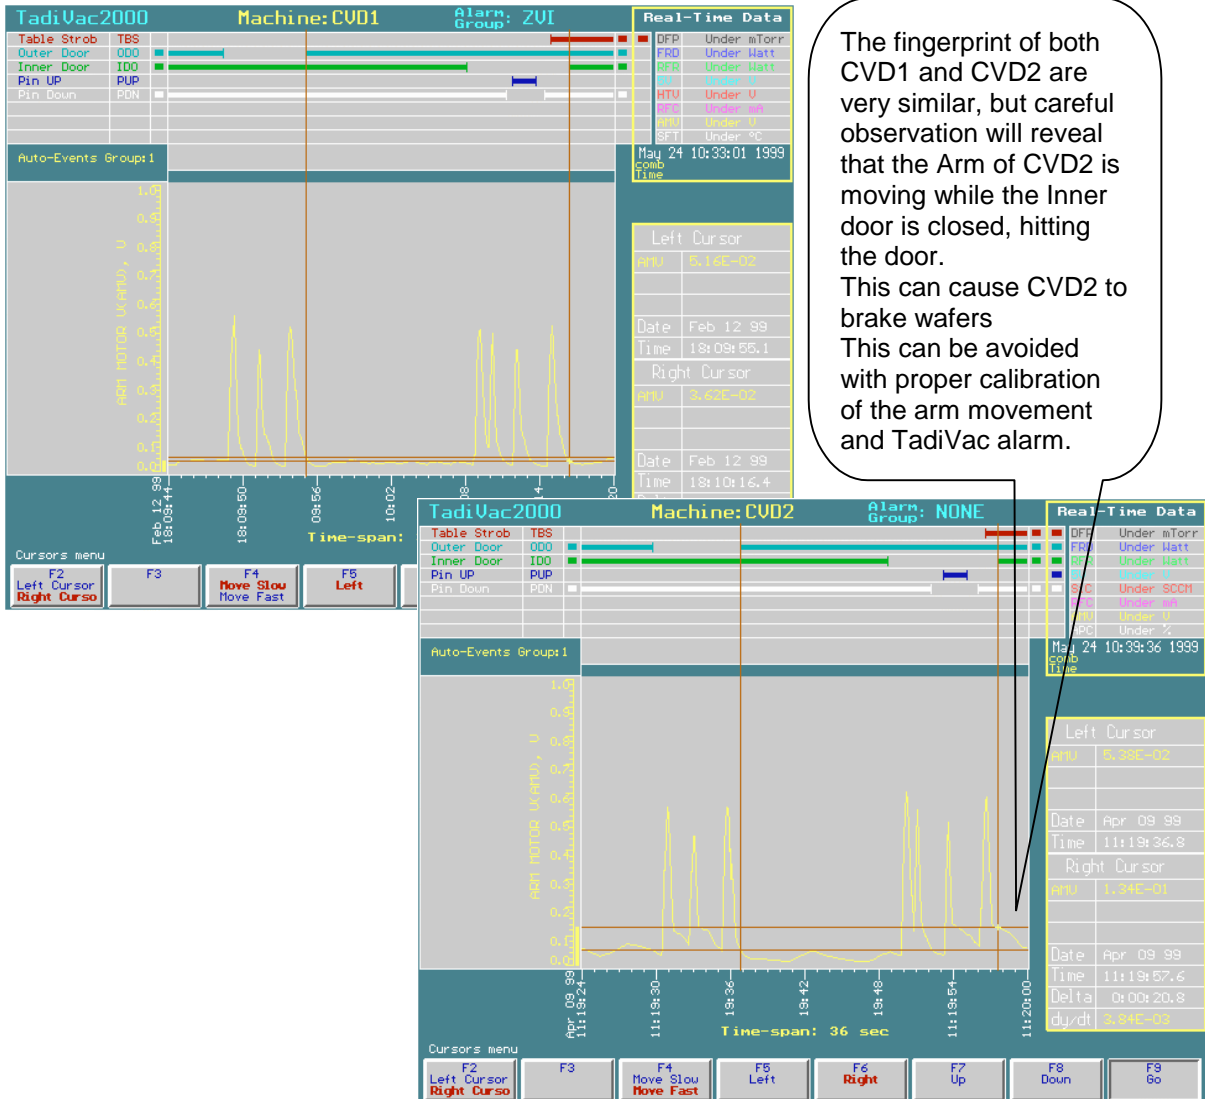
A closer observation of the Arm operation, using the TadiVac2000, reveals that CVD2 might have a wafer-handling problem. Since that data shows that the Arm is moving while the inner door be closed, which means that the Arm hits the door while loading and unloading the wafers.
