TadiVac2000 Analysis Report For Chip¹ Semiconductor CVD1 / CVD2

Revision: 03

Purpose and scope

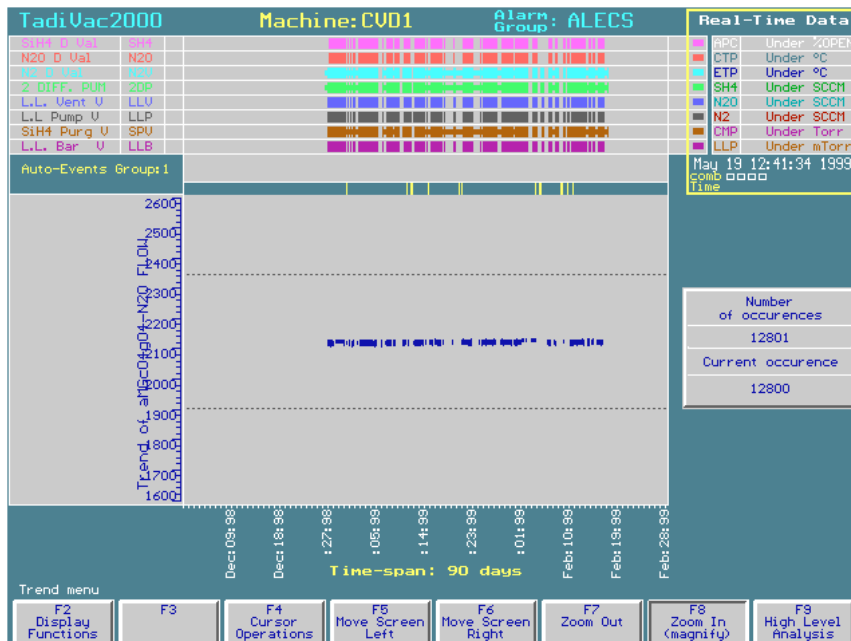
N2O flow parameter trend

A more careful observation of N20 MFC operation after clean reveals that a drift of flow is present during process. This drift might not be a cause for problems in this process, but in general it is recommended to have a stable flow.
